FORESTRY BEST MANAGEMENT PRACTICES RELATED TO WATER QUALITY- NF&NC MONITORING

SOIL QUALITY - NF&NC MONITORING

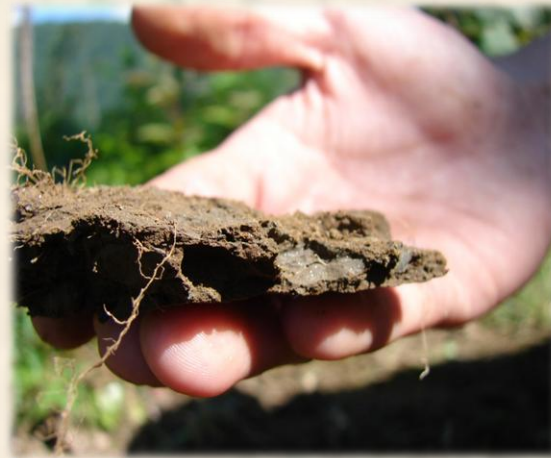
Forest	Timber Sale	Unit #	Pre-harvest (Pre) or Post-harvest (Post)	Unit Area (acres)	Percent Detrimental Soil Disturbance		
					Skid Trails & Landings	Other within Unit	Total
Nantahala	Eagle Fork	1	Post	25	2.4	0	2.4
		2	Post	16	16.3	0	16.3
		3	Post	25	9.6	1.4	10.8
Nantahala	Locust Cove	1	Post	10	0.7	0	0.7
		2	Post	18	1.1	3.2	4.4
		3	Post	17	0.5	0	0.5
Nantahala	Slipoff	8	Post	8	4.4	3.1	7.5
		10	Pre/Post	24	0.3/3.6	0/3.3	0.3/7.0
		11	Pre/Post	19	0/6.3	0/0	0/6.3
Nantahala	Farmer Branch	1	Pre	25	0.6	0	0.6
		2	Post	20	3.2	0	3.2
		3	Post	10	6.5	0	6.5
		4	Post	14	15.7	0	15.7
		5	Post	18	9.8	0	9.8

Compaction yielding platy soil structure on skid road in Farmer Branch TS Unit 4.

Skid roads decommissioned to remove detrimental soil impacts in Farmer Branch TS Unit 4, in 2011.

Corrective action has the Forest into 100% compliance with the 15% guideline in these surveyed harvest units.

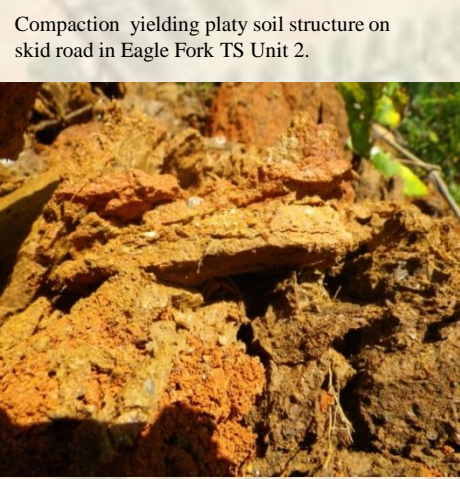
Compaction yielding platy soil structure on skid road in Eagle Fork TS Unit 2.

Skid roads decommissioned to remove detrimental soil impacts in Eagle Fork TS Unit 2, in 2012.
